Four chemical methods of porcelain conditioning and their influence over bond strength and surface integrity

João Paulo Fragomeni Stella¹, Andrea Becker Oliveira¹, Lincoln Issamu Nojima², Mariana Marquezan³

DOI: <http://dx.doi.org/10.1590/2176-9451.20.4.051-056.oar>

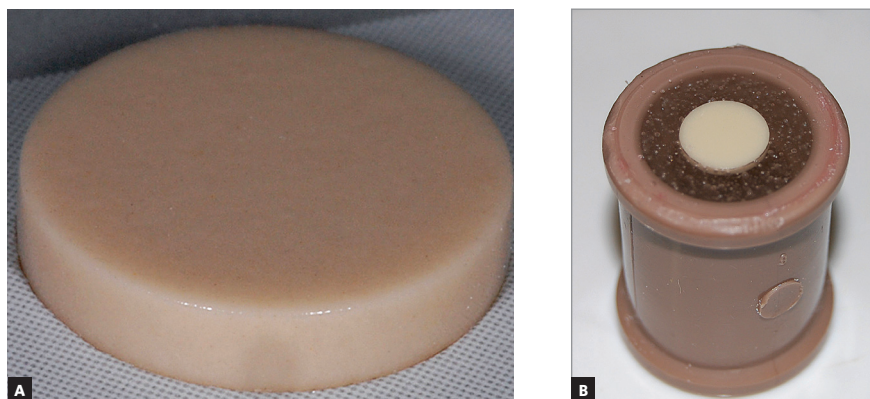
Figure 1 - A) Feldspathic ceramic cylinder; B) Sample ready for the experiment.

This research had an experimental *in vitro* study design. Fifty-two feldspathic porcelain cylinders of the VITA VM13 system, (Wilcos do Brasil, Petrópolis/RJ, Brazil), 2.2 mm high and 10.4 mm wide, with glazed surfaces, were used in this study (Fig 1A).

The ceramic cylinders were inserted into PVC tubes filled with self-curing acrylic resin. During embedment, the ceramic samples were pressed against a wax sheet so that they remained stationary. Subsequently, the PVC tubes were placed near the ceramic disks, taking care to ensure that the samples remained centered. Finally, self-curing acrylic resin was poured into the tubes. Samples were ready for the experiment immediately after the acrylic resin was polymerized (Fig 1B).
