Impact responses of slender composite plates for bird-strike testing of fan blades

Abstract

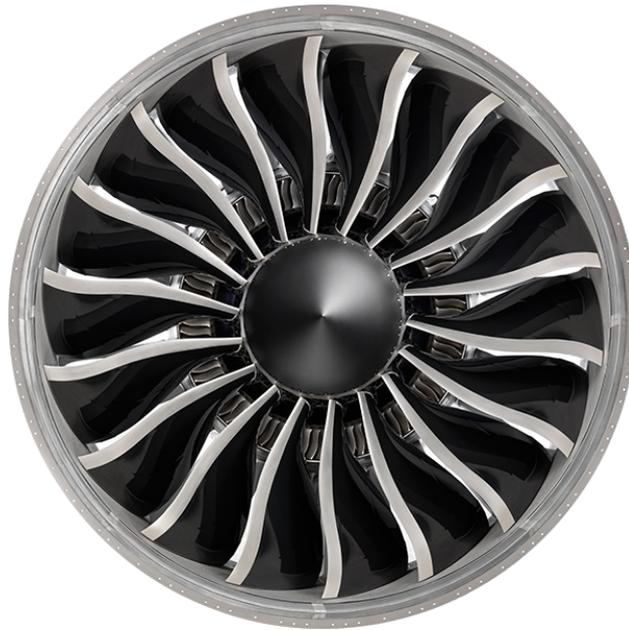
Fig. 1. Carbon-fiber composite fan blades of GENx engine

For the real complex twisted fan blades (e.g. the carbon-fiber composite fan blades of GENx engine (The GENx Commercial Aircraft Engine, 2019), as shown in Fig. 1), the most susceptible regions are the impact contact area and the leading edges of the blade (Vignjevic et al., 2013), which slice the bird projectile. From the geometrical profile of the blade, the “stagger angle $\phi(s)$ ” at the impact location s due to pretwist in the airfoil can be expressed as $\phi(s) = \phi_0 + \phi's$ (Sinha et al., 2011). An example of fan blade airfoil and its profile sections are as shown in Fig. 2. The impact-induced peak strain was observed to locate at the leading edge of the blade (Teichman & Tadros, 1991). The impact region experiences the maximum Hugoniot pressure (p_H), which is evaluated by $p_H = \rho_0 V_0 V_s$, where ρ_0 is the initial density, V_0 is the initial velocity and V_s is the velocity of shock wave. Vignjevic et al. (Vignjevic et al., 2013) presented that there was a strong influence of bird impact location on the extent of blade deformations. In terms of simplified blade-like components in experiments, however, the maximum impact damages are always located at the root of cantilever slender plates (L. Liu et al., 2018b), which is determined by the characteristic of the structure and loading types. The flat slender plates can be considered as beam-type structures, and hence the bending moments achieve the maximum at the clamped end under bending deformations. Therefore, the similarity between the simplified testing and real operating situation should be intensively considered. Li et al. (Y. Li, Zhang, & Xue, 2008) studied the similarity law of bird strike for purpose of the small-scale experiment to replace a full-scale one. Mazzariol and Alves (Mazzariol & Alves, 2019a, 2019b)

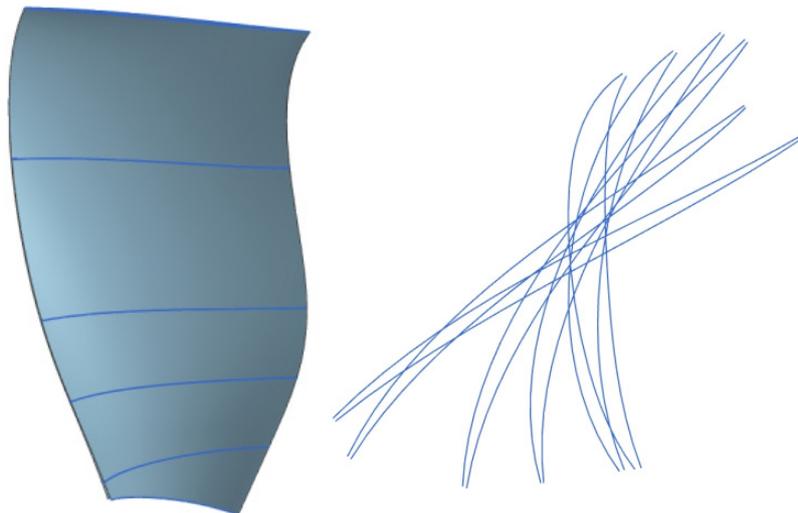
Fig. 2. An example of fan blade airfoil and its profile sections

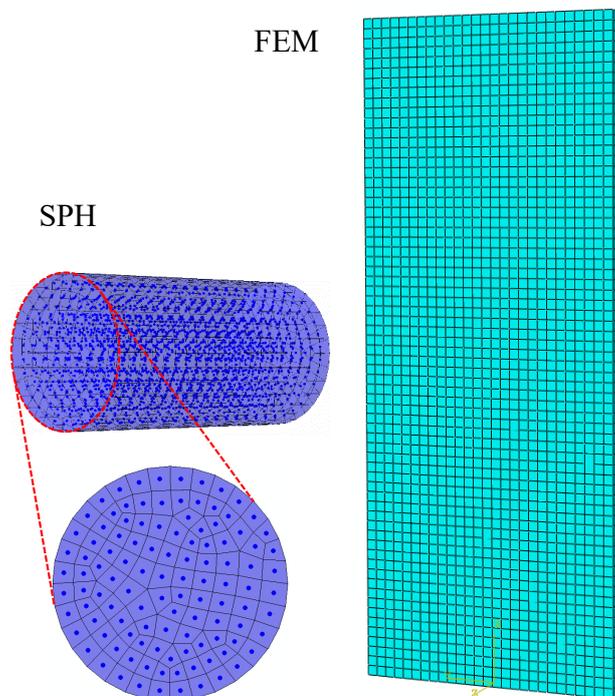
Fig. 3. SPH-FEM model for bird-strike simulation

The cylindrical projectile was widely used to simulate the bird body (Michele Guida, Marulo, Polito, Meo, & Riccio, 2009; Heimbs, 2011), with the length-to-diameter ratio of 2. The geometric and mass details for present simulations are listed in Table 1. The smoothed particle hydrodynamics (SPH) method is applied to describe the bird fluidic behaviour at high velocities. The laminated blades are modelled by finite element method (FEM), with a total of 1809 linear quadrilateral elements of type S4R used in ABAQUS software. The composite ply was modelled as a homogeneous orthotropic elastic material. The plane-stress formulation was adopted and the in-plane stress components are $\sigma = [\sigma_{11}, \sigma_{22}, \sigma_{12}]^T$. A total of 2220 linear hexahedral elements of type C3D8R were created firstly, and then these elements were converted to SPH particles as the explicit dynamic analysis began. The SPH-FEM model is as shown in Fig. 3. The initial velocity of the bird projectile was 120 m/s.

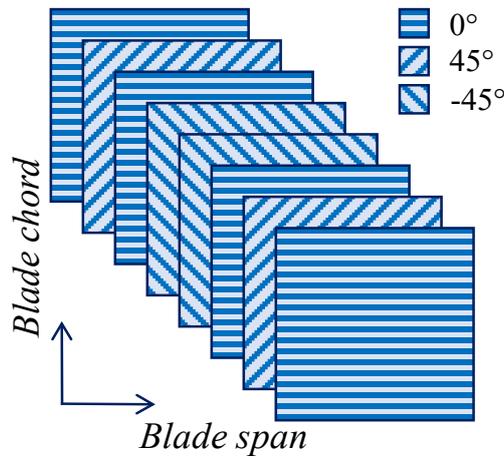
The stacking sequence of the unidirectional lamina is as shown in Fig. 4. A total of 16 layers was used. The 0° direction (longitudinal direction) is along the blade span.

Fig. 4. Stacking sequence of the composite plate (with the symmetric half displayed)

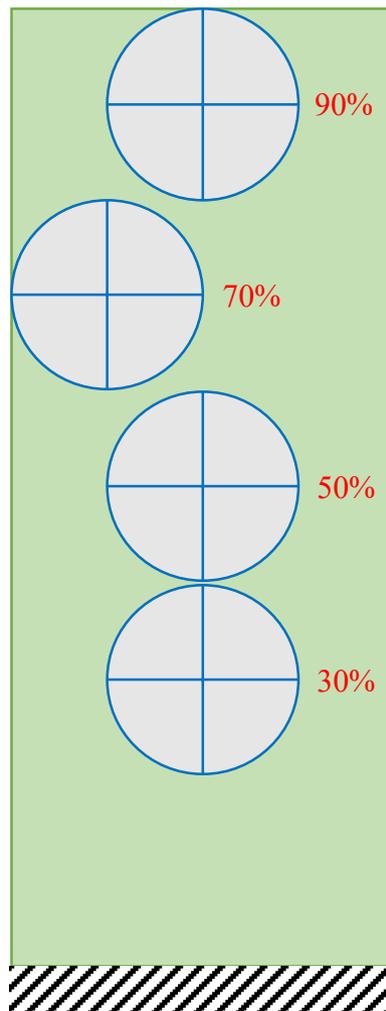
Firstly, the different impact locations were considered, as illustrated in Fig. 5. Among the four locations, 30%, 50% and 90% heights of the blade span are distributed on the axis of symmetry, while the 70% height of span is eccentrically located, which is for purpose of torsional effect on the impact responses.

Fig. 5. Different impact locations on the blade

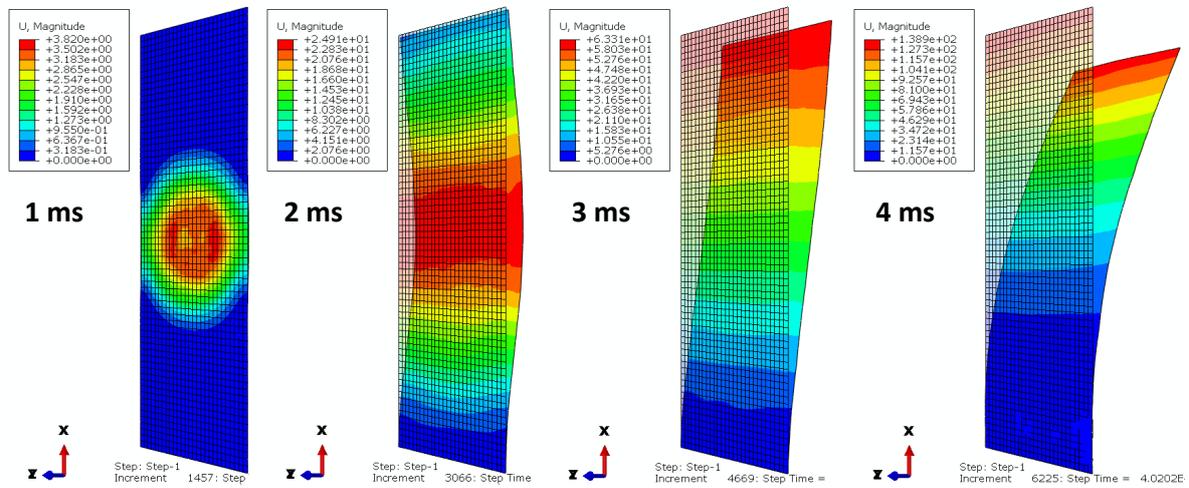
Fig. 6 show the deformation series of the 50% height case, i.e. impacted on the geometric center of the plate. It can be seen that the plate behaved as the simply-supported middle-loaded beam at the beginning (1 and 2 ms); and then the deformations became globally, and the blade tip experienced large deflection. Because of the symmetry of both the loading and structure, the plate deformed symmetrically in the impact process.

Fig. 6. Deformation series of the 50% height case

Fig. 9 shows the deformation series of the eccentrically-impacted 70% height case. Because the impact loading was not symmetric, the torsion-bending coupling deformations appeared in this case. From Figs. 6-9, it can be observed that the impact location has a significant influence on the deformation mode of the flat blades. Impacted at different locations, the bending as simply-supported beam, the bending of cantilever beam, the bending with behind shifting, and the bending-torsion coupling deformation modes appeared respectively.

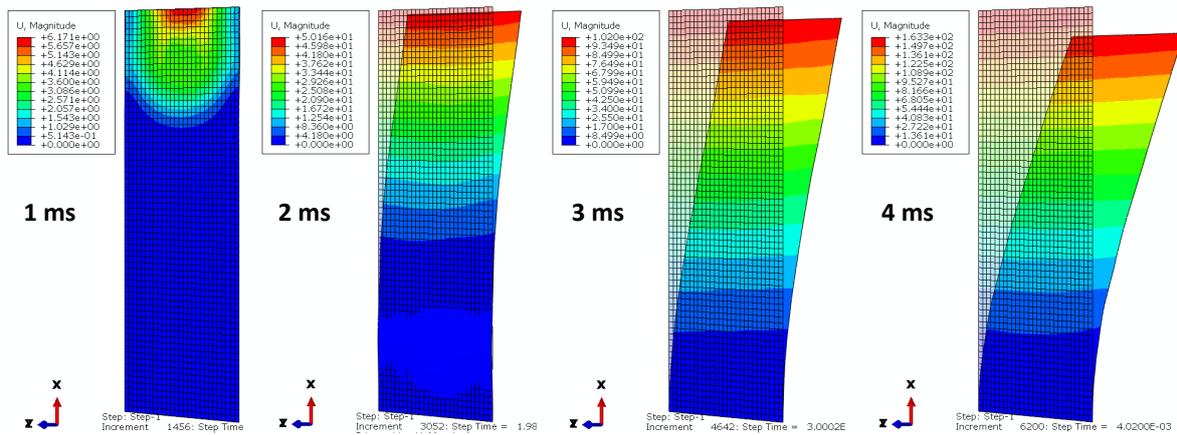
Fig. 7 gives the deformation series of the 90% height case, i.e. impacted on the location near the blade tip. It can be seen that the plate behaved as the cantilever beam in the whole process. The deflections are also symmetric.

Fig. 7. Deformation series of the 90% height case

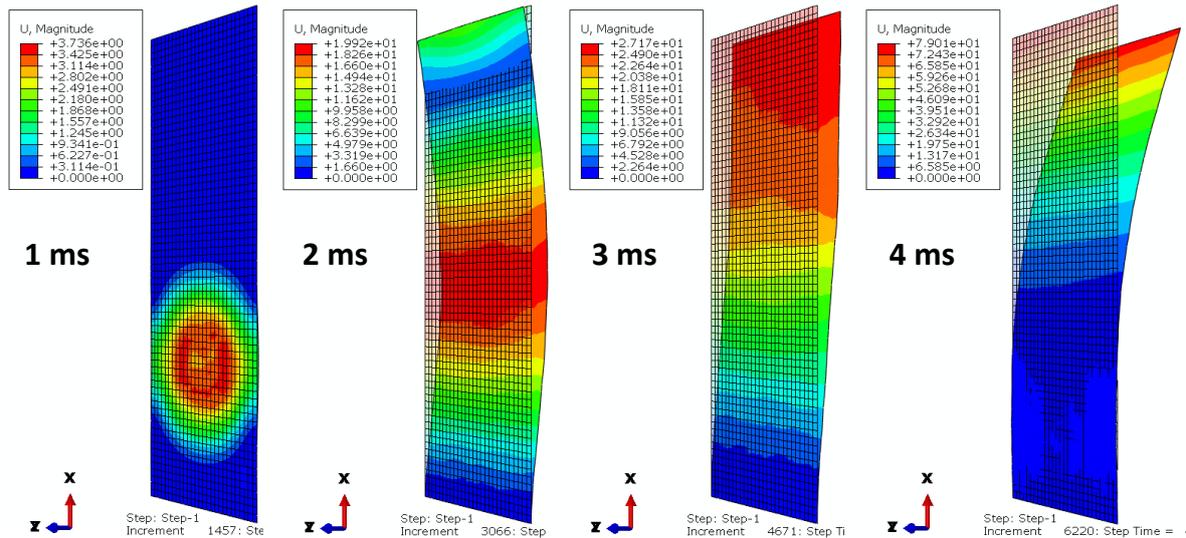
Fig. 8 gives the deformation series of the 30% height case, i.e. impacted on the location near the blade root. It can be seen that the plate deformed at the contact region in the beginning; and then maximum deflection gradually extended to the blade tip in the process of impact. In particular, the blade tip experienced a behind shifting due to the inertia force.

Fig. 8. Deformation series of the 30% height case

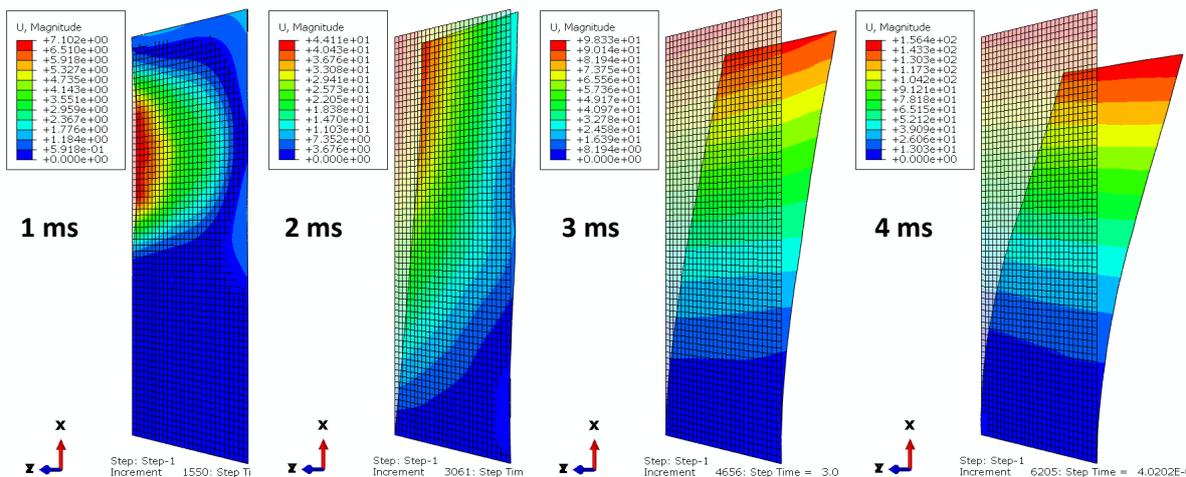
Fig. 9. Deformation series of the eccentrically-impacted 70% height case

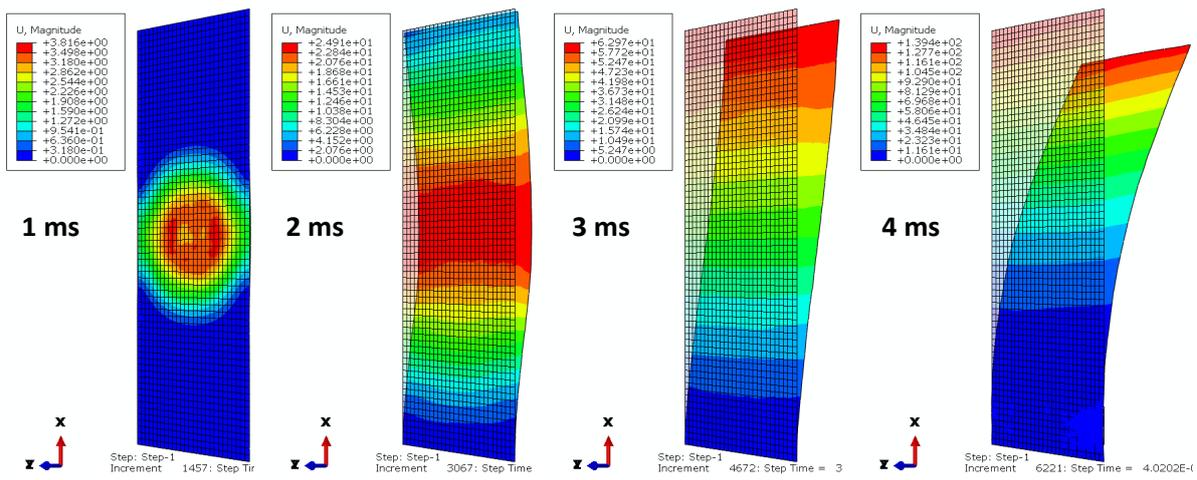
The second considered strategy was to use an additional mass. The non-structural mass was placed in the middle of the blade tip. At beginning, a mass point with 1 kg was used. The results of deformation series of the 50% height with 1 kg point mass are shown in Fig. 10. The displacement responses are rather similar with the case without point mass. Hence, the point mass was then increased to 4 kg. The deformation series of the 50% height with 4 kg point mass are shown in Fig. 11. The displacement responses were almost no difference with the case with 1 kg point mass. Therefore, it can be seen that additional mass has little effect on the impact deformation mode.

Fig. 10. Deformation series of the 50% height with 1 kg point mass

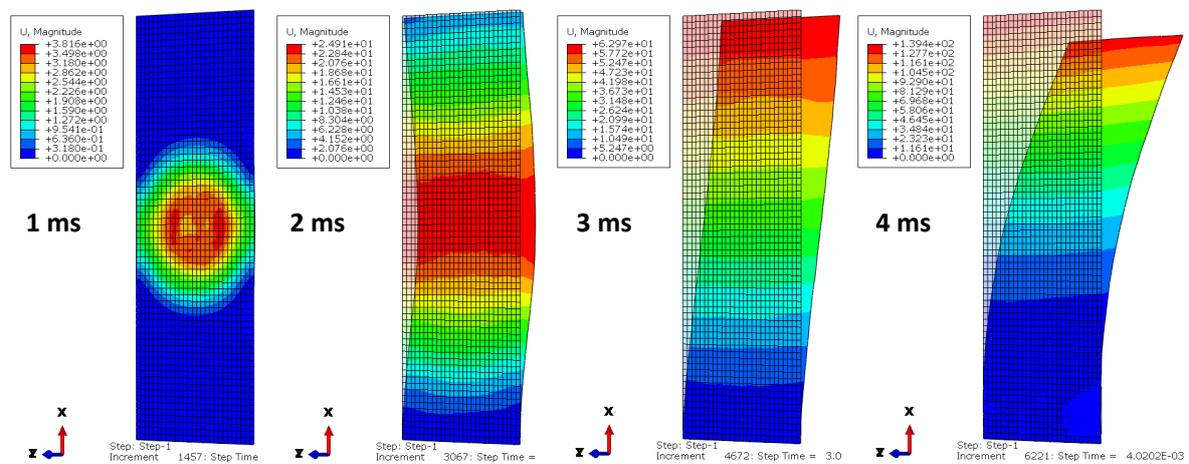
Fig. 11. Deformation series of the 50% height with 4 kg point mass

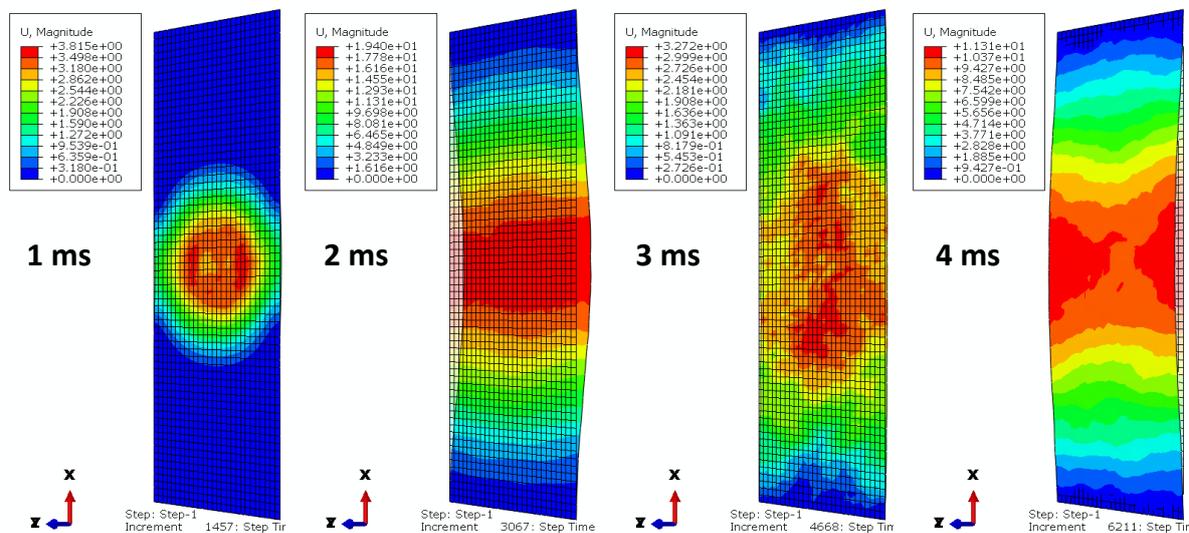
The third considered strategy was to change the boundary condition. A clamped-clamped boundary condition was applied. Fig. 12 shows the deformation series of the 50% height with clamped-clamped boundary condition. It can be seen the displacement responses were largely changed. The maximum deformation distributed in the middle of the blade throughout the impact process. The plate experienced bending vibrations with high frequencies. In brief, the effect of boundary conditions on the impact responses is very remarkable.

Fig. 12. Deformation series of the 50% height with clamped-clamped boundary condition

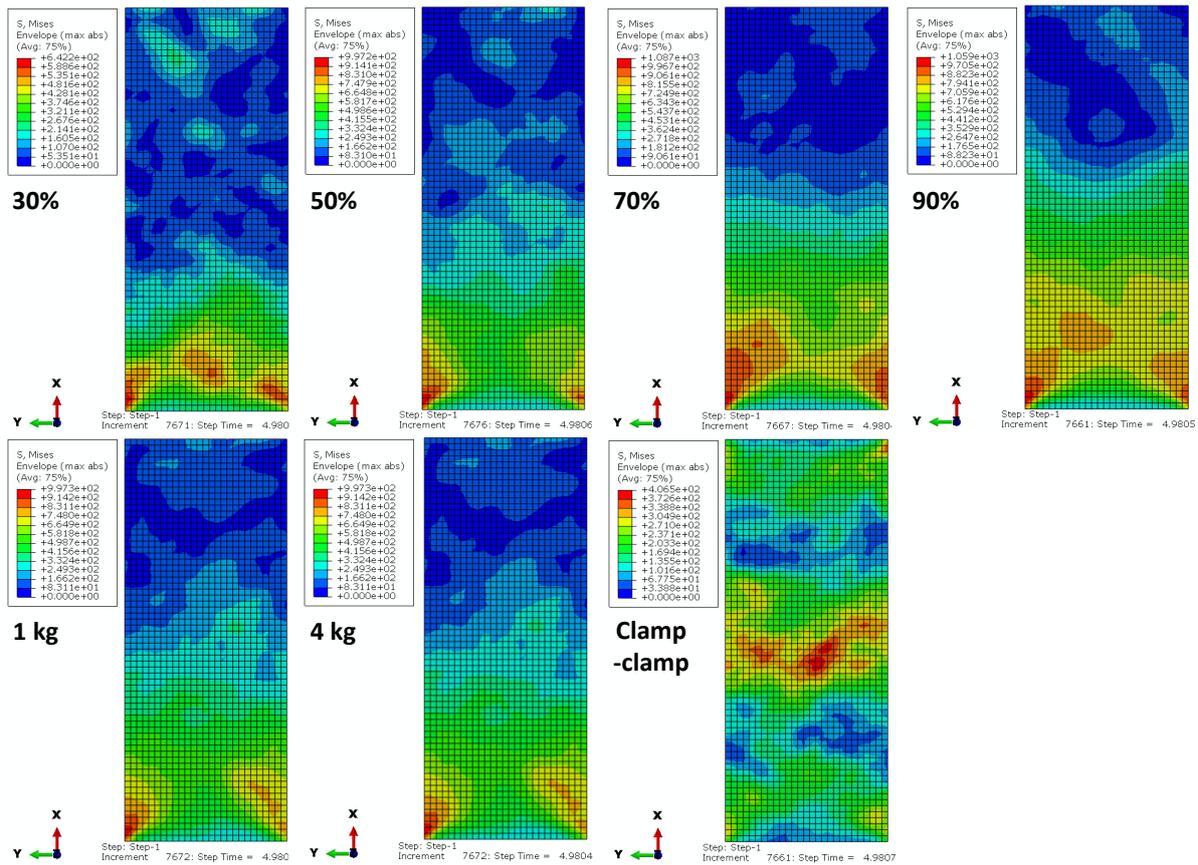
Fig. 13. The von Mises stress distributions of the above-mentioned seven blades at 5 ms

Different displacement responses generate different stress distributions, and the latter is straightforward related to impact failure. The final goal is to obtain desirable stress distributions, which are convenient for damage mechanism study. Fig. 13 gives the von Mises stress distributions of the above-mentioned blades at 5 ms. It can be seen that the impact location can influence the stress distributions, but the maximum stresses are all located at the blade roots for the cantilever cases. And then, additional mass has little effect on the stress responses. At last, the maximum stress of the clamped-clamped plate is distributed at the middle of the blade, and the peak value is smaller than those of any other cases. Thus, the clamped-clamped plate can be considered as a preferable surrogate case for impact testing of real fan blades.

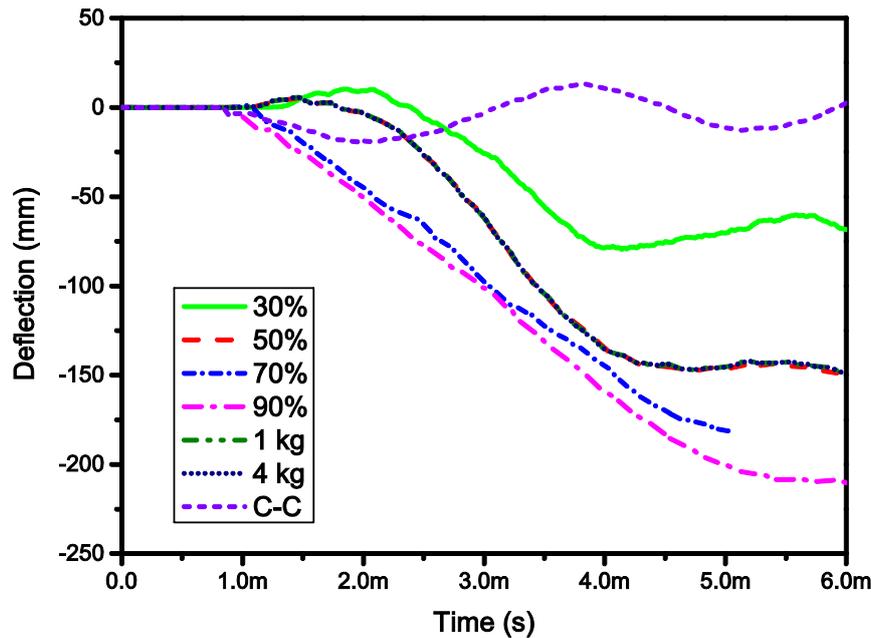
Furthermore, in order to observe the dynamic process more completely, the time histories of the maximum deflections are compared. The maximum deflections locate at the blade tips for the cantilever cases, while locates at the plate centre for the clamped-clamped case. Fig. 14 plots the computation results. On the whole, the deflections increase as the impact locations move from the root to the tip. Then, it can be seen that the point mass has no effect on the deflection histories. In particular, the deflection history curve of clamped-clamped case exhibits a harmonic oscillation around the initial position, which is totally different from those of the cantilever ones. These results can provide a reference for both moderate deflection and stress responses in future simplified plate-level experiments.

Fig. 14. Time histories of the maximum deflections in the seven considered models (C-C: clamped-clamped boundary condition)
