CLINICAL INFORMATION

When one port does not return blood: two case reports of rare causes for misplaced central venous catheters

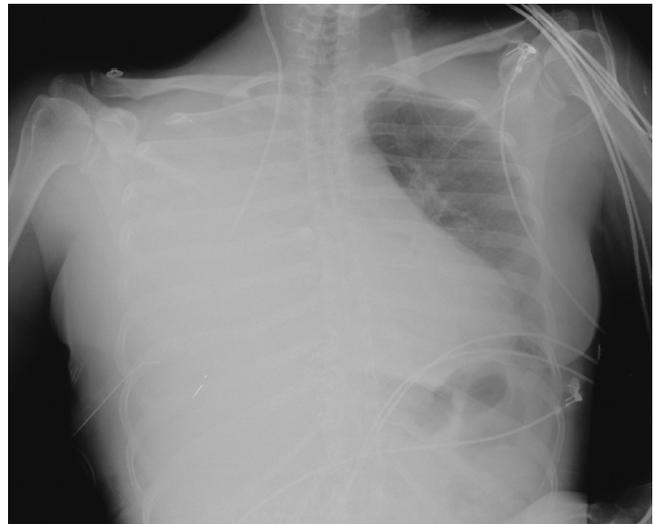
The chest radiograph showed opacity on the right hemithorax and the catheter tip was noted to be in the opposite direction of the cardiac silhouette (Fig. 1).

Figure 1 Portable chest X-ray showing right hydrothorax 9 h after insertion of the central venous catheter.

A chest tube was inserted with immediate drainage of 2500 mL of serous fluid accompanied by symptomatic relieve. The patient was transferred to the ward. The chest tube was removed after 5 days and she was discharged, fully recovered.

explained by the close proximity of the superior vena cava to the right pleura.³ This complication is usually described in cases of progressive vascular erosion of an initial intravascular catheter,^{4–6} and may be associated with the poor positioning of the tip or an unsafe catheter fixation with back-and-forth movement.⁷ In our case the absence of blood return on aspiration of the distal port suggests, however, not erosion but a vascular lesion at insertion, representing, as far as we know, the only case of a complication of this kind.

In our case the restriction in fluid therapy intended at keeping a low central venous pressure during a partial hepatectomy probably contributed to the delay in diagnosis.
