Panorama do fechamento de mina em Minas Gerais, Brasil

Overview of mine closure in Minas Gerais, Brazil

Despite closure regulations being recent in Brazil, many mining companies are attempting to adopt best practice and are facing the challenge of closing their mines properly instead of simply complying with current legislation or abandoning the mine site. This paper summarizes mine closure according to both the Brazilian legislation and the “Deliberação Normativa” COPAM N° 127, that establishes the directives and procedures for environmental assessment at the mine closure stage. Even with the lack of laws and regulations addressing mine closure, the Brazilian mining industry today is at the forefront of environmental impact minimisation techniques. Some case studies in Minas Gerais State, two of them located in the Iron Quadrangle, provide excellent evidence of the industry’s rehabilitation expertise. This paper presents an overview of mine closure legislation in Brazil and in the State of Minas Gerais and gives some examples of mine closure programmes in effect. It is intended to highlight the changes on mine closure requirements as well as the best practices on mine closure in

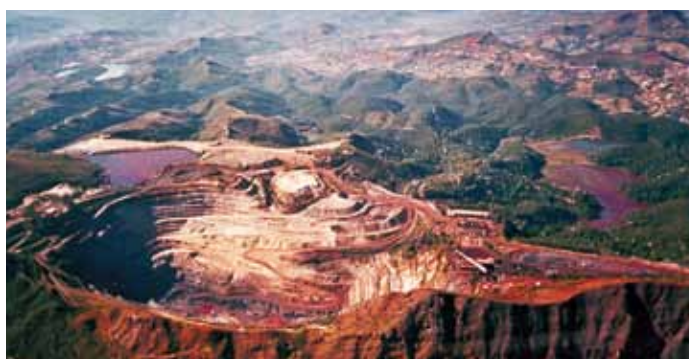
Figure 1
Aerial view, from 1998, of the Águas Claras Mine from the top of Curral Mountain. Source: MBR courtesy.

The Águas Claras Mine operated from 1973 through 2002, (Figure 1). The first large mine in Brazil being closed, its closure is probably a remarkable point in the Brazilian mining industry, under the sustainable development point of view. The location and physiography of the area

favour an anthropogenic post mining use, a village, surrounded by the preserved Jambreiro Forest and the lake being created in the depleted pit. The closure plan establishes the creation of an urban centre in an area of 194 ha that represents 9% of the total area. This urban centre will

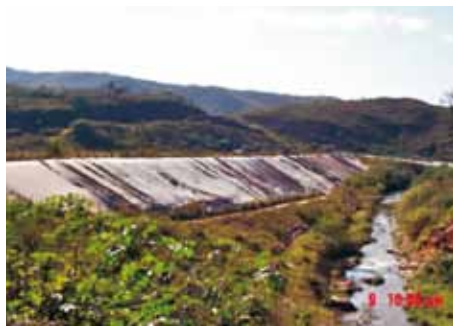
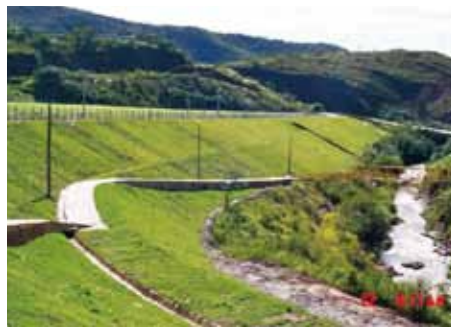
Figure 2
Galo tailings deposit before rehabilitation (left) and after rehabilitation (right).
Source: Anglo Gold Ashanti courtesy.

Besides Mina Velha decommissioning programme, Anglo Gold Ashanti is conducting rehabilitation activities of old tailings deposit in Nova Lima (Figure 2). To address the potential hazard associated with the historic tailings disposal practices, a rehabilitation project was initiated in 1995 covering the old tailings dumps and the arsenic recovery plant site. This included a massive revegetation programme at a cost of US\$500.000,00. Studies and consultancy findings from 2002 indicated that tailings encapsulation would be required to avoid future risk of human exposure.

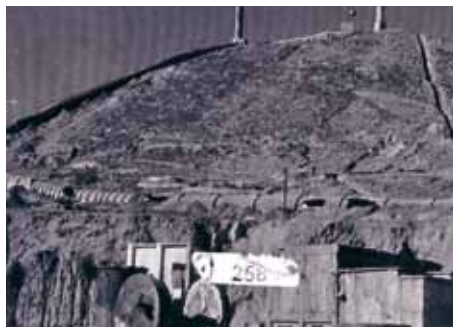
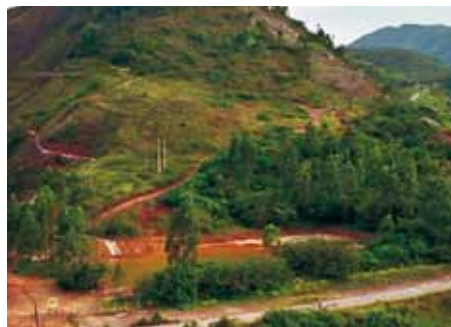
Figure 3
Morro do Galo hillside before rehabilitation (left) and after rehabilitation (right).
Source: A picture from Milton Nascimento Record called Sentinela, 1980 (left) and AngloGold Ashanti courtesy (right).

of topsoil and tailings from the Morro do Galo old arsenic trioxide recovery plant. The Morro do Galo hillside has now been completely rehabilitated and the Galo tailings deposit is in its final stage of recovery (Figure 3). In 2005, the programme included the old tailings deposits at Resende, Matadouro and Fabrica de Balas being concluded in 2006. An extensive communications programme has been undertaken with the local residents (some 40 families - approximately 160 people - surrounding the Morro do Galo and Galo tailings deposits). The cost of about U\$4 million was estimated for this rehabilitation programme (Anglo Gold Ashanti, 2004; Alves, et al. 2008).

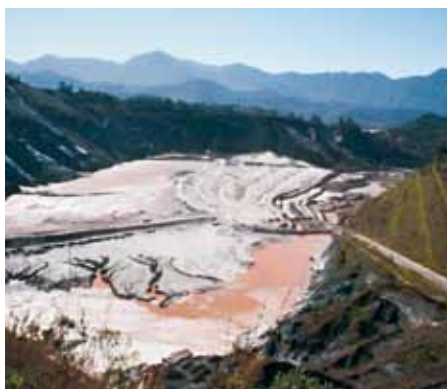
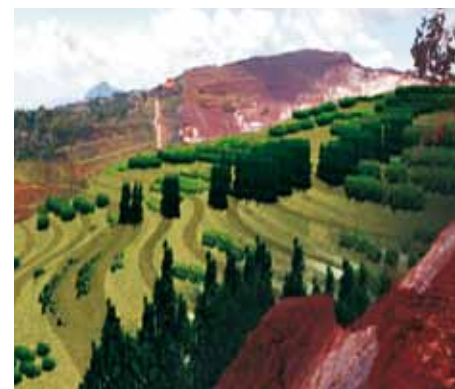
Figure 4
Germano pit Phase 1 construction (left)
and final pit illustration after Phase 2
revegetation (right).
Photo Samarco courtesy.

tailings reservoir. Geotechnical studies defined the final angle of the sand filling to 18° and a maximum safe height of 150 m. The pit-filling programme was divided into two phases. Phase 1 filling from the bottom of pit (elevation 945 m to 970 m) and Phase 2 from elevation 945 to 1,100 m (Figure 4, left). Burle Marx, the world-renowned Brazilian landscape architect, developed a conceptual landscape project as part of the rehabilitation programme (Figure 4, right).

Phase 1 sandy tailing pile begun in 2001, with foundation excavation and building of a drainage blanket (internal drainage system) and a start-up dike. A pumping system was used to build the

sandy pile raised by upstream method. Stability management during construction included the installation of piezometers and inclinometers plus periodical safety inspections. The sandy tailing storage volume loaded at Phase 1 was 5 x 106 m³. Phase 2 includes building of start-up dike and drainage blanket (internal drainage) and drainage gallery, pumping system to dispose the sandy tailing in the 2nd phase pile, installing of piezometers/ inclinometers and safety inspections. Sandy tailing storage capacity will reach 48 million m³. 16 years are estimated for sand tailing disposal in the pit at a cost of US\$2 M (Phase 1), US\$8M (Phase 2) and US\$ 2M for vegetation (Lima et al., 2007).

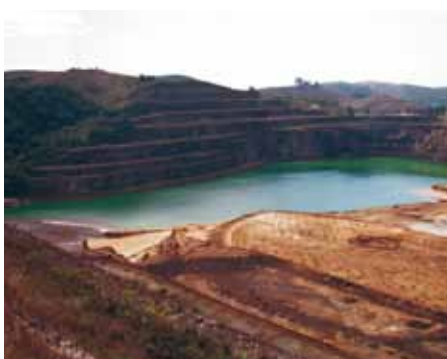
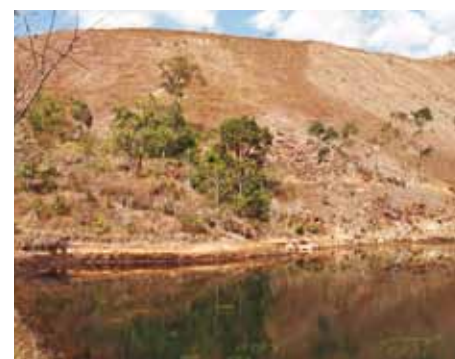
Figure 5
Osamu Utsumi pit partially filled
with water, pH=3,5 on the left and
“waste dump” 4 on the right. The lake in
bottom of the “waste dump” 4 is formed
by water drained from it, pH = 2,5.
The water from the “waste dump”
is pumped to the pit and then to
an active water treatment system.

1977 through 1996 generated $45 \times 10^6 \text{ m}^3$ of waste rock. The waste rock is characterized by the presence of low-grade uranium below 200 ppm of U_3O_8 . Out of the five waste rock piles, two of them, named “waste dump 4 and waste dump 8” have produced large amounts of acid drainage (Figure 5 on right). The plant running at full was able to process 2,500 ton of ore/day and produce 400 ton/year of concentrate. Solid and liquid wastes were sent to a tailings dam. Since the beginning of operation, control actions were taken to minimize environmental impact, such as (Cunha et al., 2006):

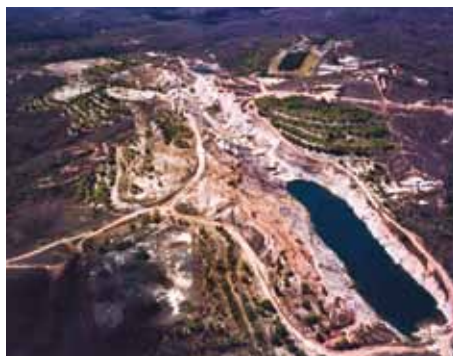
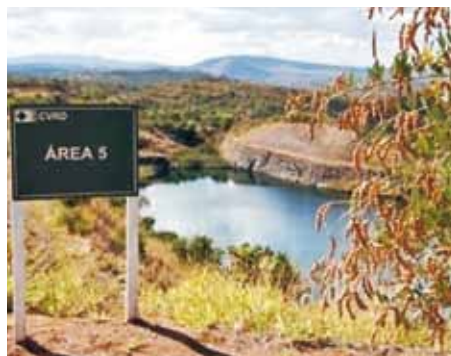
Figure 6
A view of Riacho dos Machados Mine immediately after closure in 1988 (left) and North Pit rehabilitate by Vale. Vale courtesy.

Riacho dos Machados was an open-pit oxide heap-leach gold mine where Vale ran operation from 1989 through 1997 (Figure 6, right). The mine was located in the small town that gave the name to the mine, 150 km North of Montes Claros, North of Minas Gerais. Its main economic activity before and after the mining operation is fruit and cotton growing and cattle breeding. The region is semi-arid with savannah vegetation. There are only two watercourses and one dam, which are essential to these economic activities. 250

3,220,000 ton of gold ore were extracted: 6,878,739 ton of waste rock to produce 4.8 ton of gold. In 1997, the operation was shut down. The environmental rehabilitation activities took place in 2002 and according to Vale's environmental management system the monitoring and maintenance programme was planned to last 5 years. The pit was filled with water becoming a lake (Figure 6 right). The waste rock piles and tailings beach were covered
