# **SOIL EROSION ANALYSIS IN THE INFLUENCE AREA OF TIETÊ- PARANÁ HYDROWAY (TIETÊ BRANCH)**

Instituto de Pesquisas Tecnológicas do Estado de São Paulo- IPT  
(Technological Research Institute)

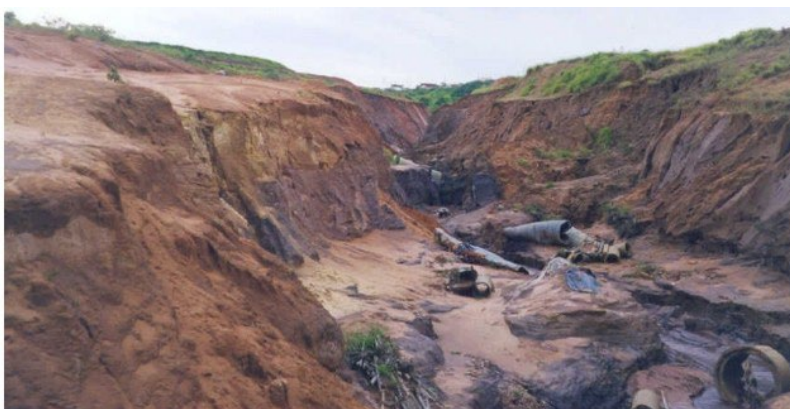
**Picture 1** - Gully erosion situated in São Pedro municipality  
(Archive IPT)

- Class I: Santa Bárbara D' Oeste, Sumaré, Ipeúna, Charqueada, São Pedro (Picture 1), Águas de São Pedro, Anhembi, Bofete and Botucatu;
- Classes II and III: Agudos, Bauru, Pirajuí, Balbinos, Itaju, Iacanga, Borborema, Taquaritinga, Cafelândia, Birigui, Araçatuba, Guararapes and Novo Horizonte.

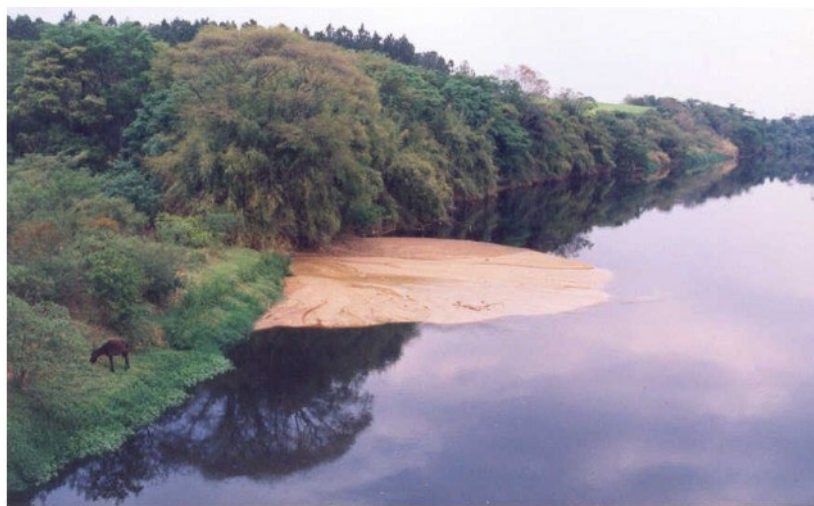
**Picture 2** - Silting up in Piracicaba river caused by erosion from Santa Bárbara D'Oeste urban area (Archive IPT).

The environmental impact due to silting up process is very clear in many parts along the Tietê river and its affluents (Picture 2). It can be observed vast deposits of sediments along river channels. Most of them are recent sediment deposits composed by unconsolidated materials caused by man-made activities and prone to be retransported to lower points of the drainage system.
